Manhole Inspection Summary

Manhole # S45K__022MH

Insp Date: **4/30/08 10:24 AM**

Location Address: **s castle street**

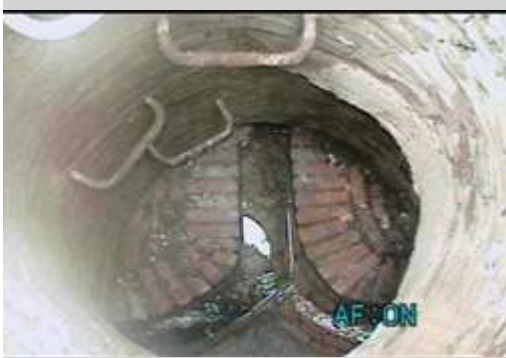
Top View

Condition: **Cracked**

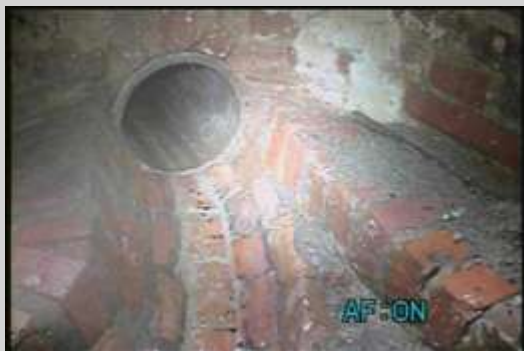
3 O'Clock Inflow

8 in. Circular Gravity Sewer
Pipe In @ 3 O'Clock

Pipe Material: **Clay** ☐ Pipe Lined

Invert Depth: **8.21** (ft.) Flow Characteristics: **None**

Deposits: ☒ **None** ☐ Mud ☐ Sludge ☐ Debris ☐ Grease

Infiltration: **None** Pipe Seal Cond: **Unknown**

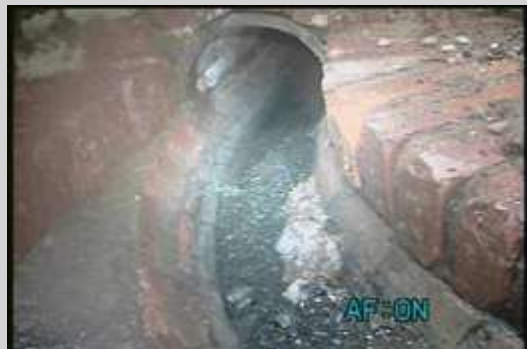
9 O'Clock Inflow

8 in. Circular Gravity Sewer

Pipe In @ 9 O'Clock

Pipe Material: **Clay** ☐ Pipe Lined

Infiltration: **None** Pipe Seal Cond: **Unknown**
